Colibri Scan Report

Nummernschild
GD PT 120
VIN

Datum
12.5.2023 16:18

Kunde
PDR-Team GmbH

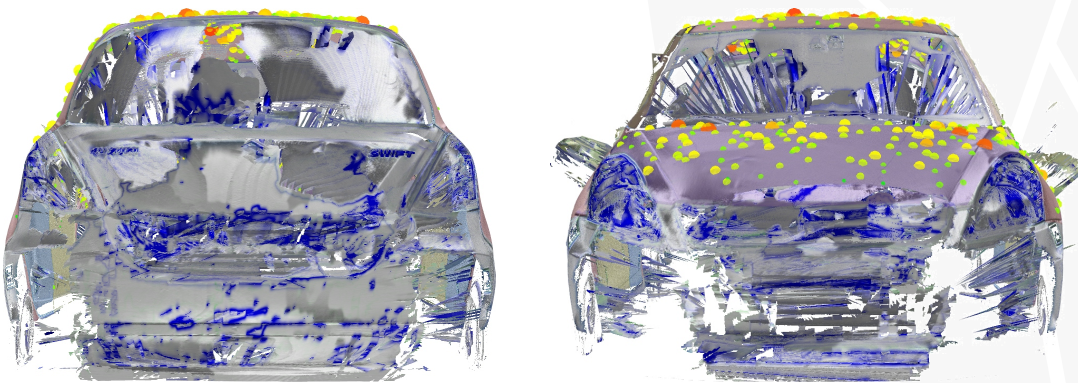
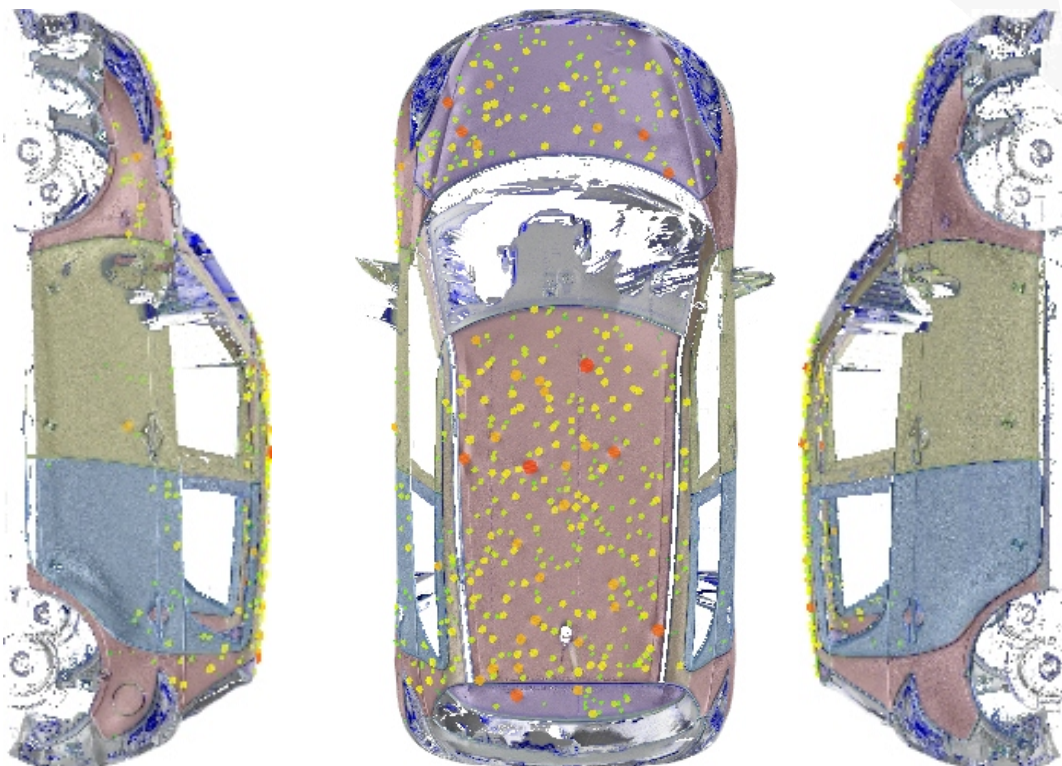
10	20	30	40	50	60	70	80	Gesamt	
Horizontal	Motorhaube	4	36	53	33	3	4		133	Ø 31 mm
	Dach	11	63	115	70	18	3	2	282	Ø 31 mm
	Heckklappe oben		10	4	1	1	1		17	Ø 28 mm
	Heckklappe unten								0	Ø 0 mm

Links	Seitenteil vorne	1	11	8	2	1			23	Ø 26 mm
	Tür Vorne	3	8	1		1			13	Ø 21 mm
	Dachholm		8	8	3				19	Ø 27 mm
	Tür Hinten	1	10	12	2	1			26	Ø 27 mm
	Seitenteil hinten	3	6	3	3				15	Ø 24 mm

Rechts	Seitenteil vorne								0	Ø 0 mm
	Tür Vorne		1						1	Ø 20 mm
	Dachholm	3	3	4	4				14	Ø 26 mm
	Tür Hinten	1	4						5	Ø 18 mm
	Seitenteil hinten								0	Ø 0 mm
